Engineering Report

GOVERNMENT CAMP SANITARY DISTRICT SEWER SYSTEM FACILITY PLAN UPDATE

Clackamas County, Oregon

December, 2022

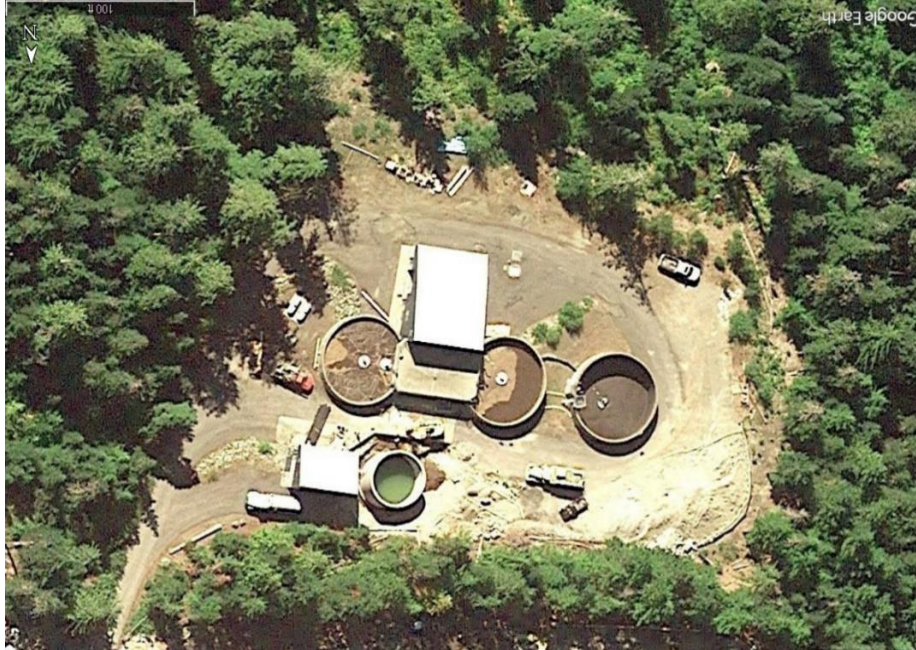
Figure 2-02. Government Camp SD Wastewater Treatment Facility Aerial

The Wastewater Treatment Facility is located west of the community of Government Camp at 85200 East Highway 26 on the south side of the highway. The treatment facility serves residential and commercial customers. The above aerial view of the treatment facility site was taken during construction of the Surge Tank.

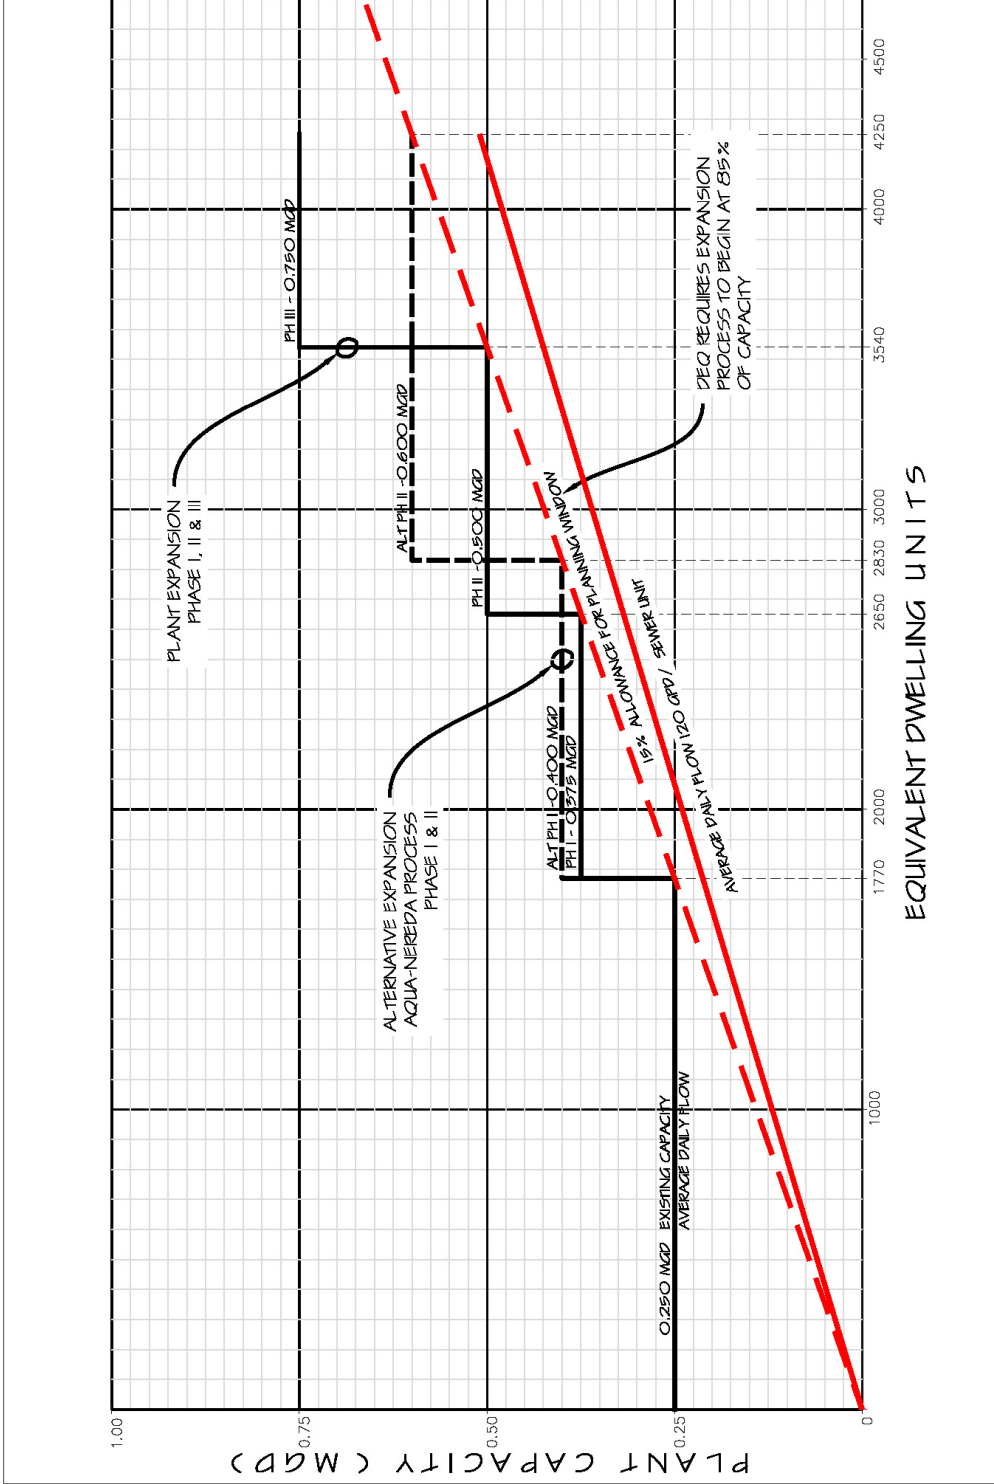
Alternatively, the dashed stepped line indicates the number of sewer units that would initiate a plant upgrade if the District adopted the relatively new Aqua-Aerobic Aqua-Nereda process. This essentially increases the capacity of the existing SBRs by an additional 60% to 400,000 gpd average annual flow, by the ability to process more batches per day.

Converting the existing SBR basins to the Aqua-Nereda process would be mandated as the number of sewer units approaches 1,770 (or average daily flows of 85% of 250,000 gpd which is the limiting capacity of the existing system). This upgrade would provide a capacity of 400,000 gpd with the two existing SBR basins. An additional SBR basin would be required as the number of sewer units approaches 2,830 (or 85% of 400,000 gpd) which would then provide a capacity of 600,000 gpd average annual flow.

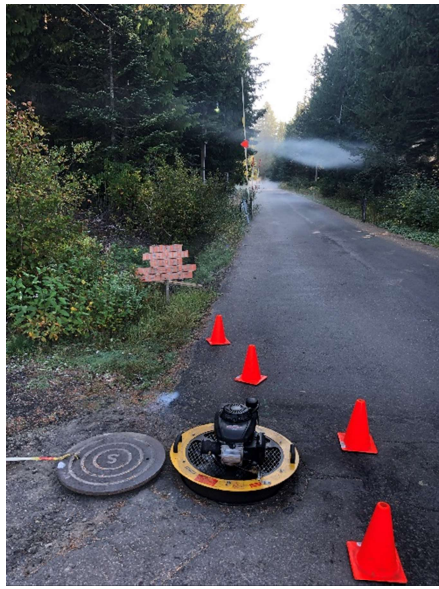
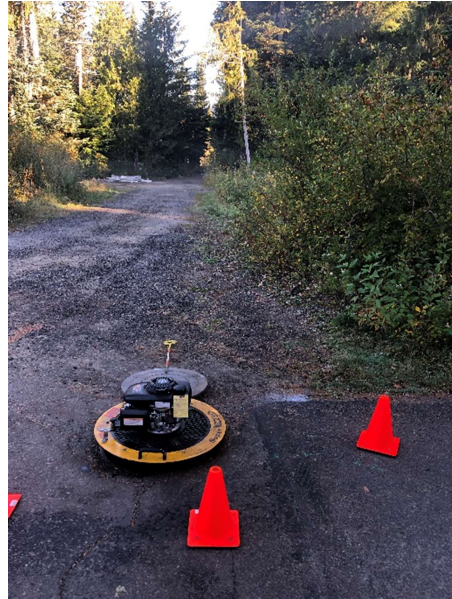
- Intersection of Frontage Rd & Bergstrasse Rd (MH BS14): Smoke coming out of pavement approx. 1' northeast of MH. Smoke came out of pavement where the white spray paint mark is. While this is to the northeast of the manhole, it does not necessarily mean this is exactly where the leak is, as the smoke will find either a crack in the pavement or easy path through landscape to the surface. However, past video logs show a line coming into the manhole from the north that has a service to the east approx. 5' from the manhole. There are no documented issues with this pipe from the video logs, but this is FDG's best guess on where the smoke could have leaked from.

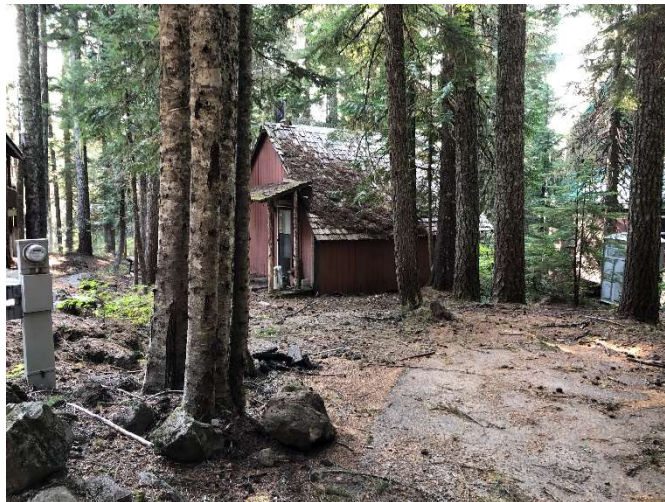
88567 E Frontage Rd: Smoke coming out around toilet of second floor bathroom. Occupant is aware of the issue and was advised by ADS technician, Tony, to notify the homeowners about leak in home's private sewer lines.

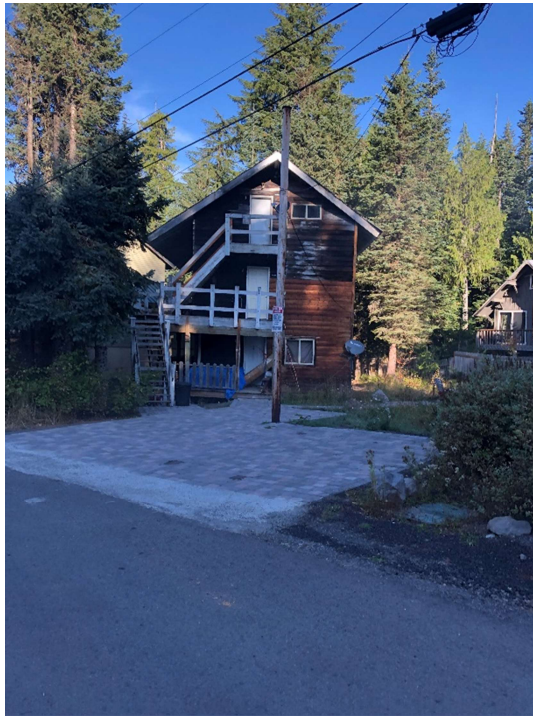
30651 E Meldrum St: Smoke billowing out of broken pipe / stub or other large opening in sanitary connections, old run-down house.

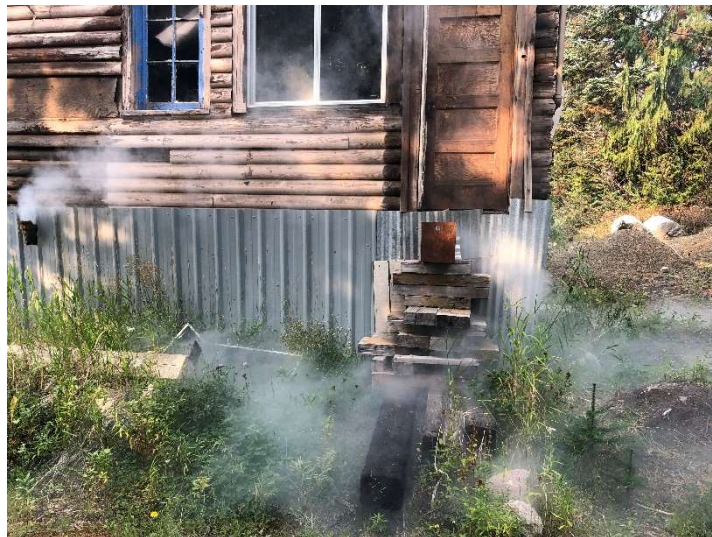
89966 E Morrison Lane: Smoke coming out of ground at edge of house. Likely coming from lateral connection. Tony, from ADS, suspected the issue to be a sheared Fernco fitting or other type of fitting. See right photo, smoke coming out where pink paint mark is.
